RADAR TYPE SG1 AND PANEL L18.

The following is an extract from a report by P.R.A.D.O. Auckland on modifications to enable panel L18 to be used with Type SG1 Radar in H.M.N.Z.S. GAMBIA.

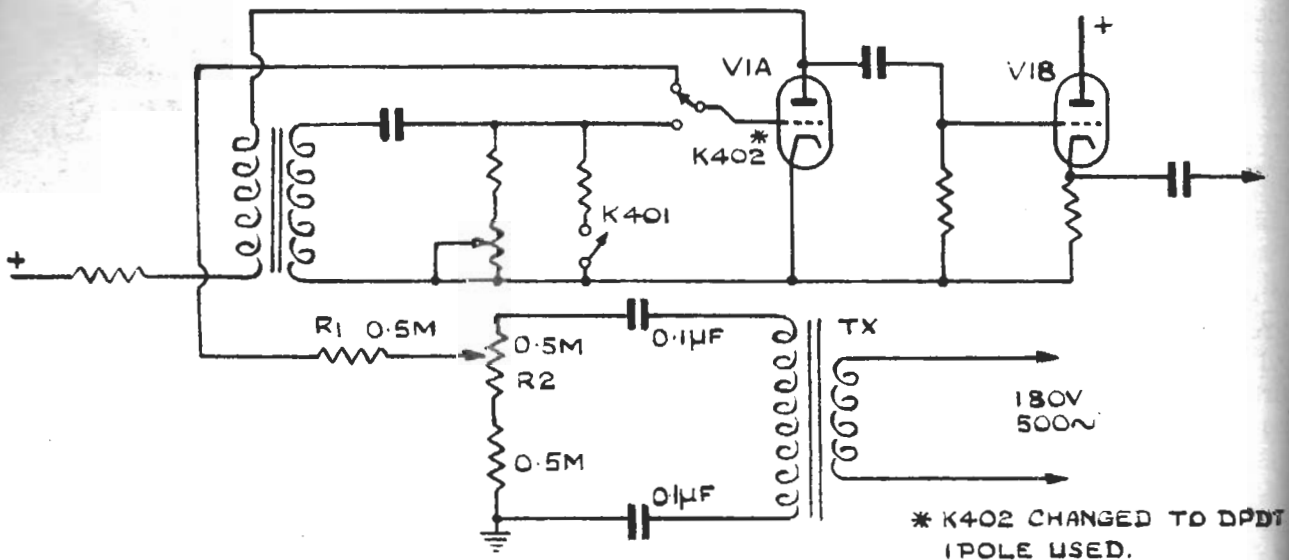
FIG. 1B

The circuit arrangement employed is shown in diagram 1 B on page 28. Diagram 1 A shows the Type SG1 oscillator before modification. Relay K402 was removed from the circuit and two position relay substituted which changes over the oscillator grid circuit from normal to panel L18 locking. It was found that at the normal power supply voltage of 180 volts applied to the grid, the output wave of V1A was insufficiently steep-fronted to provide stable locking. The transformer Tx which develops approximately 600V across the secondary was added, this produces the necessary sharp leading edge output wave of sufficient amplitude and provides stable locking. Grid stopper R1 of .5 megohm protects the valve during positive half cycles of locking voltage. R2 is adjusted to produce stable locking voltage, the required value is about 400 volts. It is necessary to watch the phasing of the 500 cycle locking voltage as in the standard panel L18 - Type 272 arrangement."

S G I OSCILLATOR - MODIFICATION & ADDITIONS FOR LOCKING WITH L18 PANEL

A practical solution which gives entirely satisfactory operation was produced by locking the Type SG1 from the 500 c.p.s. supply feeding the L18 panel, then providing synchronising and signal from Type SG1 to panel L18 in the usual manner. This was done for position A of the Type SG1 repetition rate change switch only, positions B and C remain unaltered and give normal Type SG1 800 - 850 c.p.s. oscillator controlled repetition rate.

This is a very useful modification. It is suggested that the ranging panel L17/18 should be modified in the same way as when used with Type 284, (see C.A.F.O. 1755/43). The reduced time base length will make the ranging panel less susceptible to slight phase discrepancies. It is presumed that potentiometer R2 has an effect on the phase relationship.

The voltage applied to the grid of valve V1A is large but it is probable that the valve can accept it. Ships carrying out this modification should check that the valve life remains reasonable.

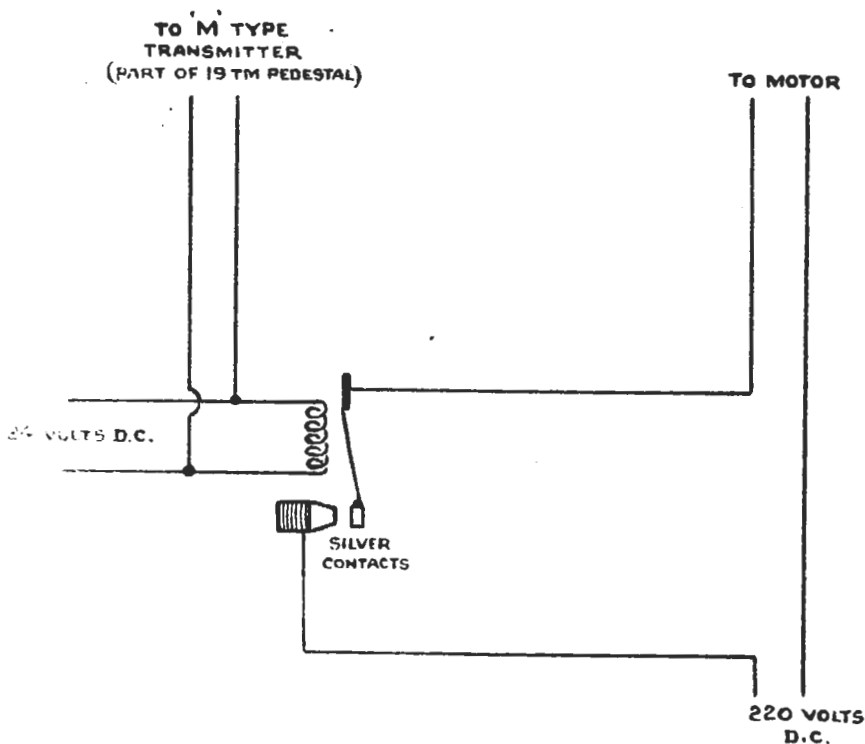
A considerable amount of trouble has been experienced with pedestal unit 19 T.M., part of Type 242 aerial array, with 400° rotation. During 18 months in service, the same defect has twice occurred and consists in the key, normally fitted into the keyway in the upright part of the pedestal, becoming adrift due to the holding bolts shearing when the spring loaded stop comes into action. When this defect occurs a block and tackle has to be rigged and the whole pedestal lowered on to the upper deck. This is no easy job and takes at least 48 hours to complete.

To overcome this defect the following system has been used. A relay operating in parallel with the 24 volt D.C. supply has been inserted in series with one side of the 220 volt D.C. supply to the motor as shown in the diagram. Thus, if the 24 volt supply is suddenly cut off the motor will not rotate. The only occasion when the spring loaded stop will come into operation is if the Type 242 aerial is switched on when the W.S. aerials are facing astern, and even then it is considered that the aerial will not bump against its stop with the same effect as if the circuit breaker pattern 54312 was fitted.

So far this has proved a satisfactory arrangement."
