RADAR TYPE SG1 AND PANEL L18.

The following is an extract from a report by P.R.A.D.O. Auckland on modifications to enable panel L18 to be used with Type SG1 Radar in H.M.N.Z.S. GAMBIA.

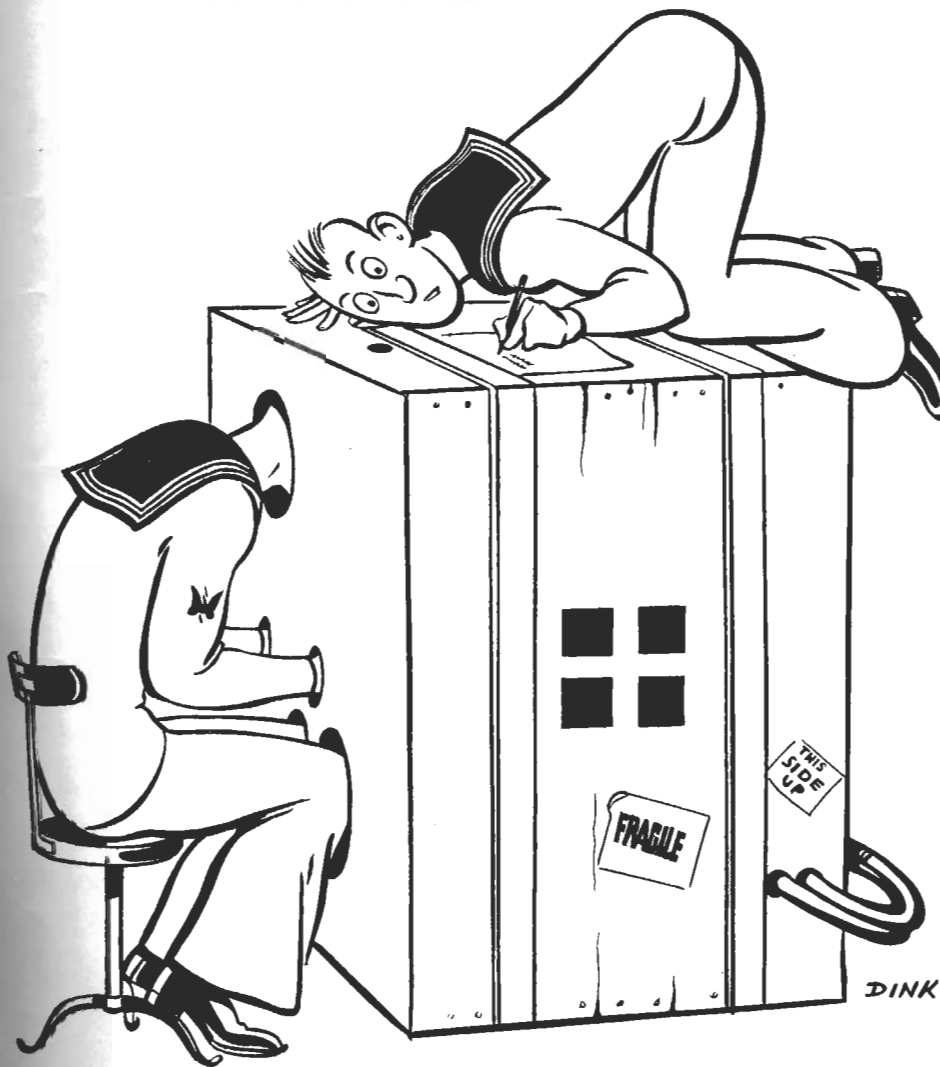
REMOVE THE CRATE!

Investigation into a complaint that A.S.E. had not allowed enough room for the installation of a set, established that it had been fitted complete with the protective packing framework.
